**RESEARCH ON USAGE OF VETIVER  
GRASS FOR  
PHYTOREMEDIATION & SEDIMENT  
CONTROL FOR THE SAN ANTONIO  
RIVER AUTHORITY IN  
CONVERSE, SAN ANTONIO, TX, USA**

**Two test sites were initiated in Florence, SC and in Converse, TX during 2015 and were worked on concurrently. However, this paper deals with the studies carried out by Dr. Rob Wayne, at the Converse, TX compost facility for the San Antonio River Authority (SARA).**

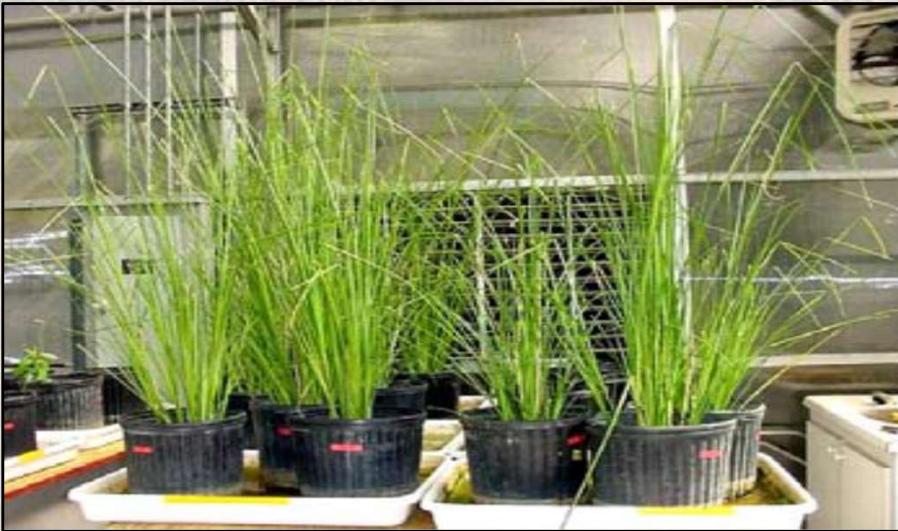
The use of Vetiver grass coupled with selected amendments has considerable potential for use as a remedial strategy for lead contaminated soils.

Chelating agent EDTA (ethylene- diaminetetraacetic acid) increased lead extraction up to 1390-1450ppm/kg.

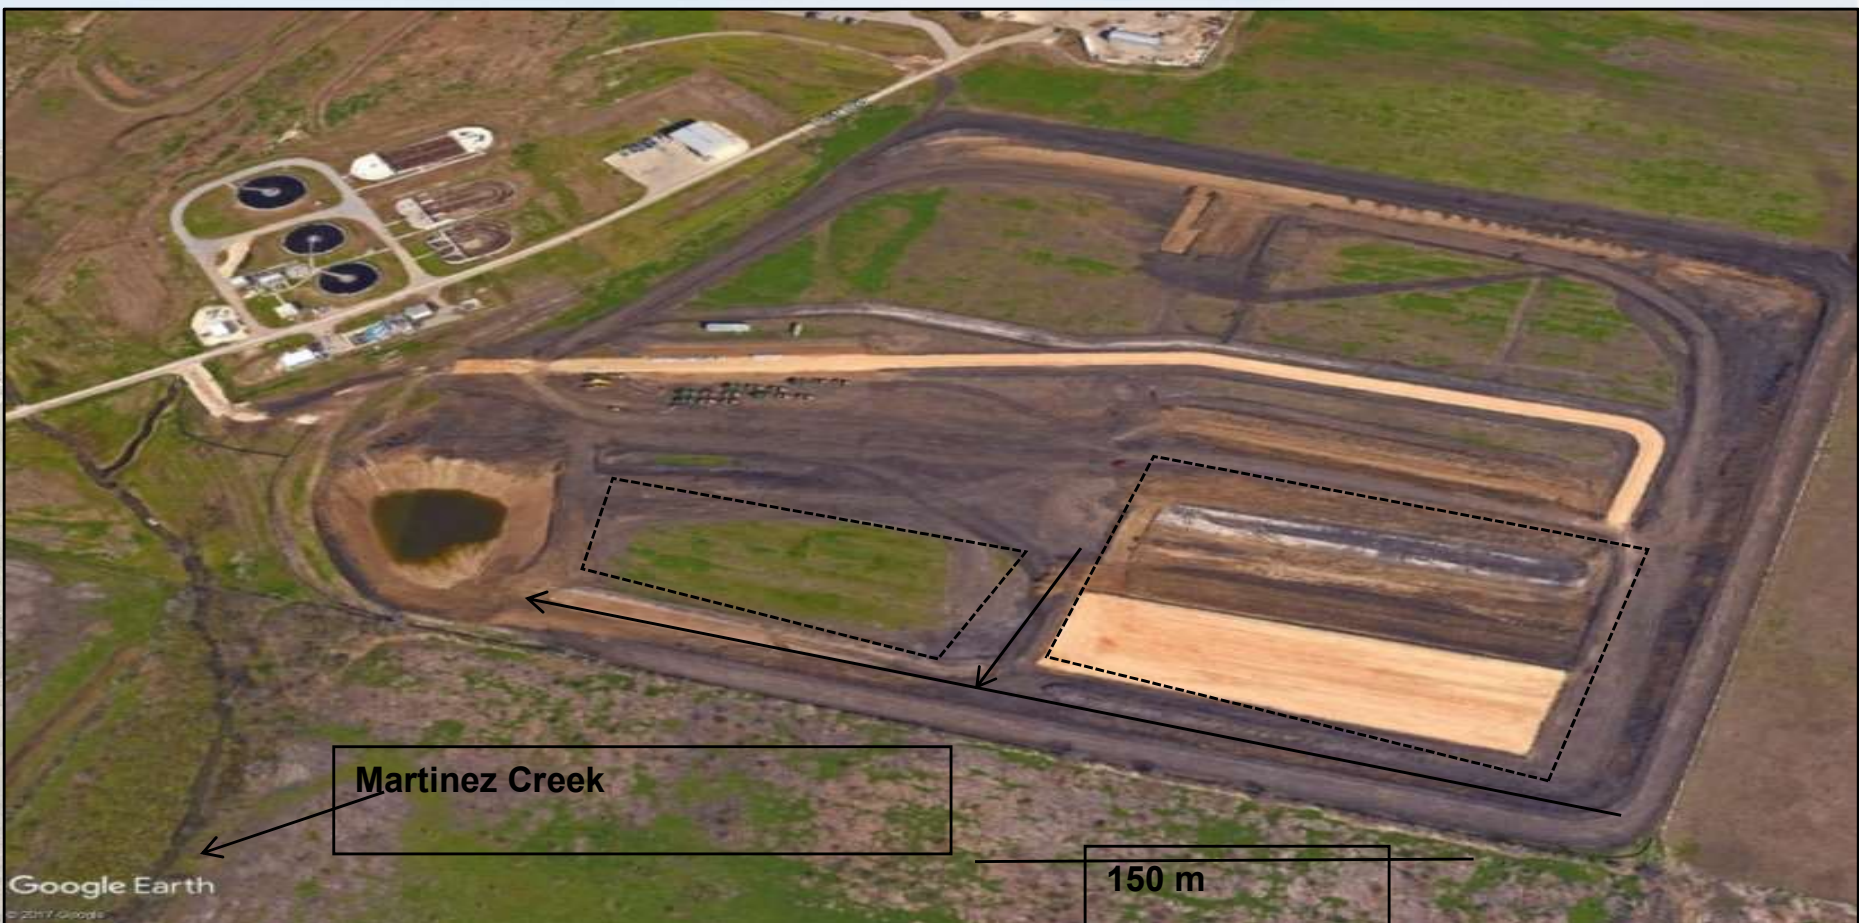
The 52-acre Martinez II site is situated 16 miles N-E from the San Antonio River. It includes a 6-acre compost pad where various materials consisting of chipped yard trimmings, biosolids, liquid, solid food waste, animal carcasses & manure, paper and other materials are processed and placed in windrows as allowed under the Texas Commission on Environmental Quality (TCEQ) composting rules.

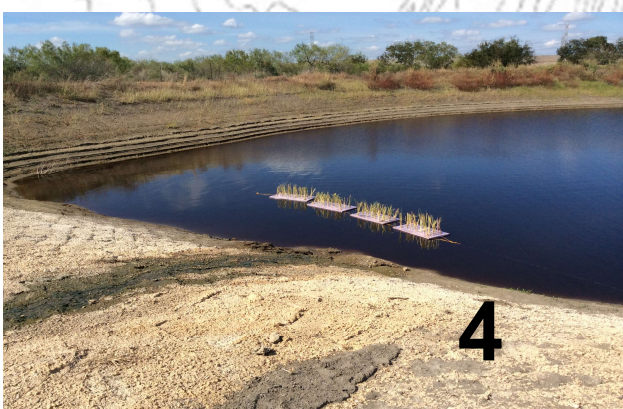
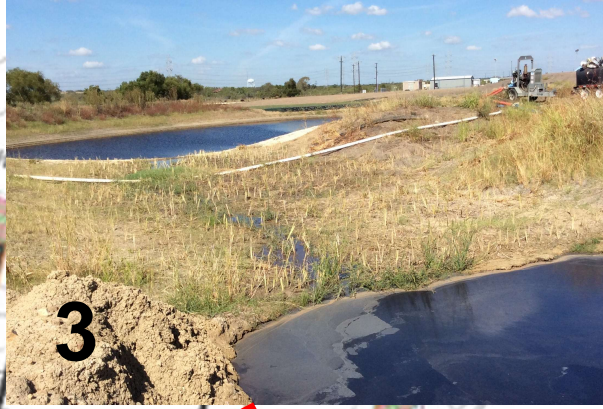
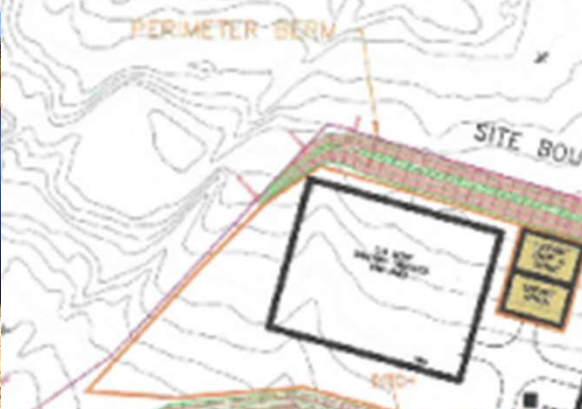
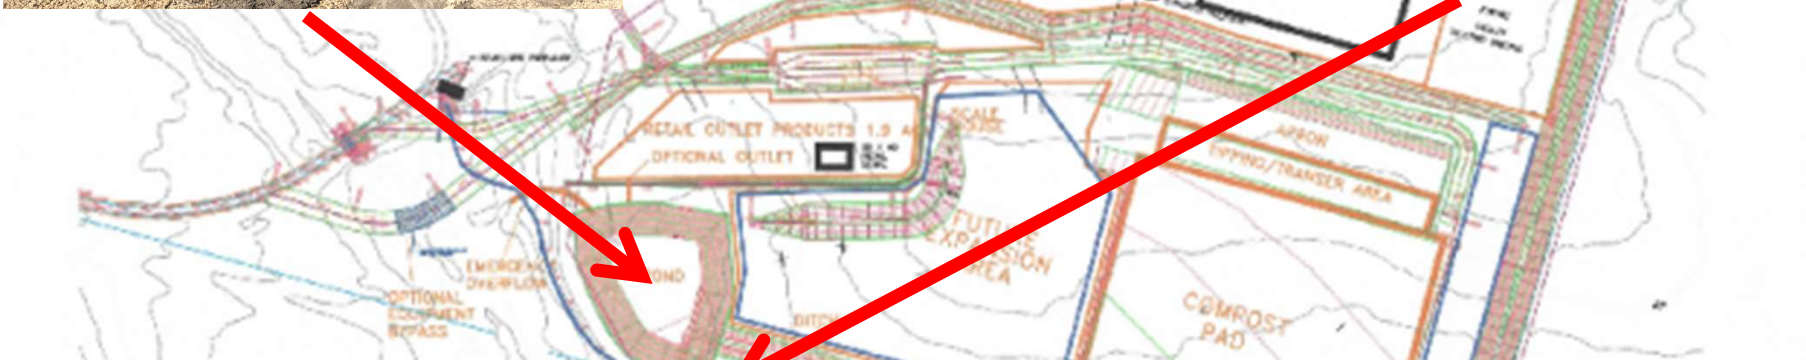
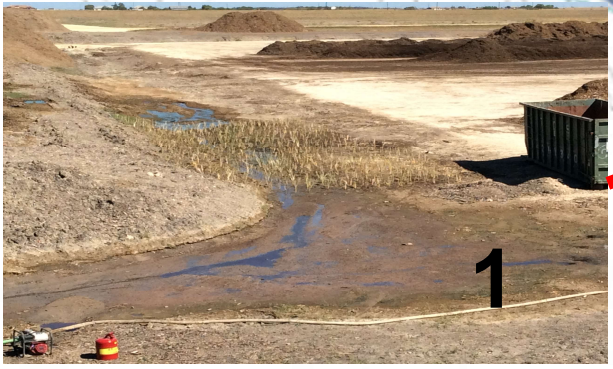
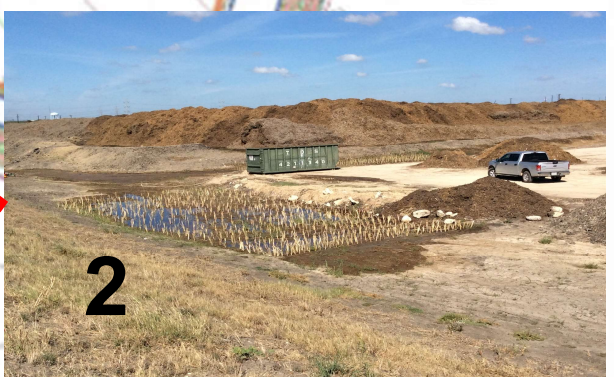
The diagram below showing the Site location 1, 2, 3 & 4 for the Vetiver trials at the Martinez site, Converse, TX.

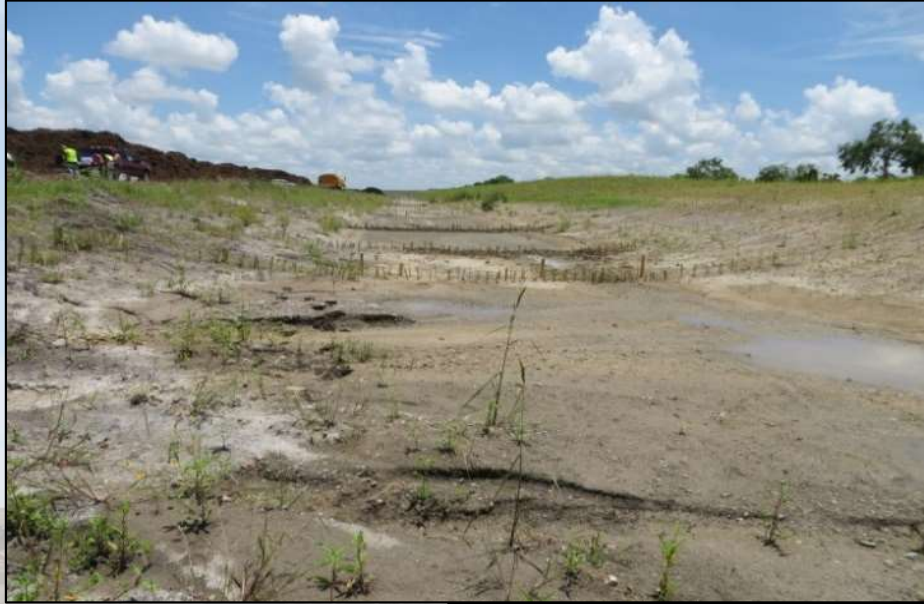
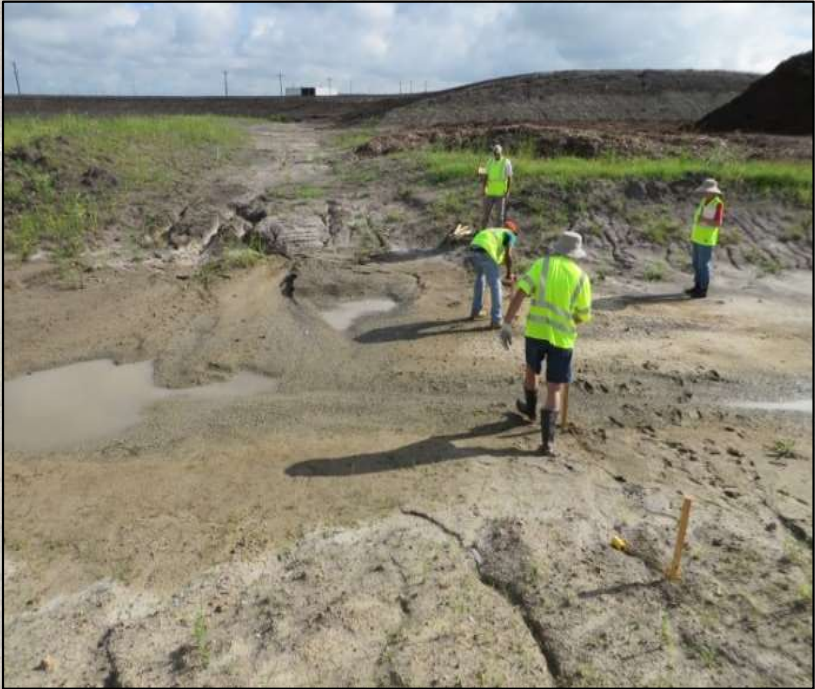
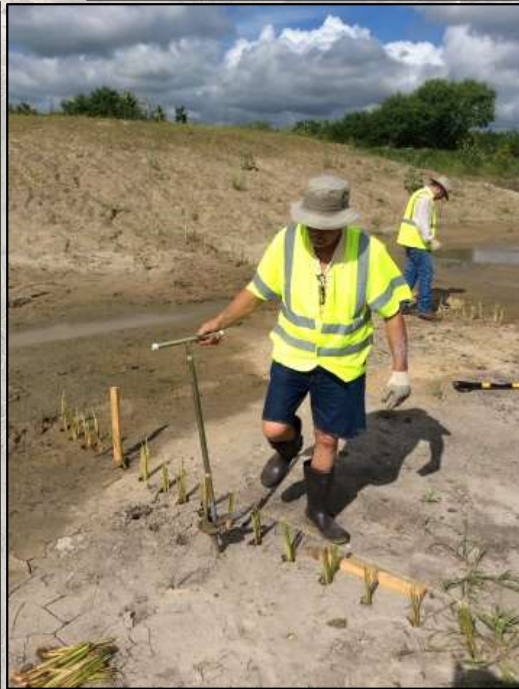
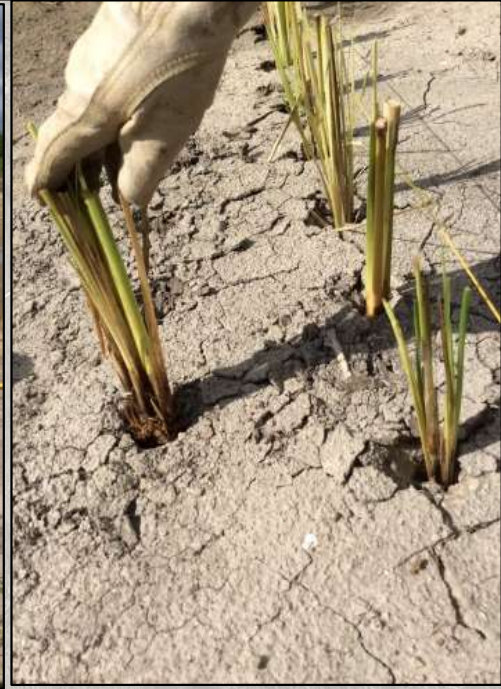
Trial set up to determine Vetivers' ability to trap sediment & to absorb minerals leaching from the composting facility & dissipating into the downstream retention pond. Seven lines of 2 rows each were set out along the pond canal at 5 plants per linear yard.

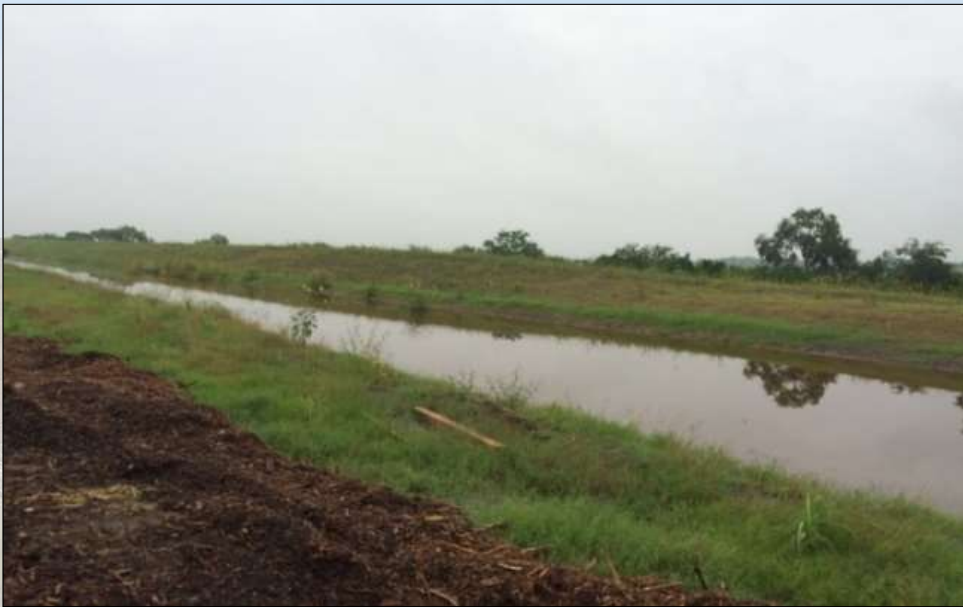
**The June 2015 Vetiver trials were subjected to extreme dry & hot conditions. Most of the planted Vetiver grass did not survive as a result of the extensive and intense heat (103°F). Excessive ponding of the discharge canal from a 6.5-inch rainfall storm on 24 June, submerged the plants for around 10 weeks.**

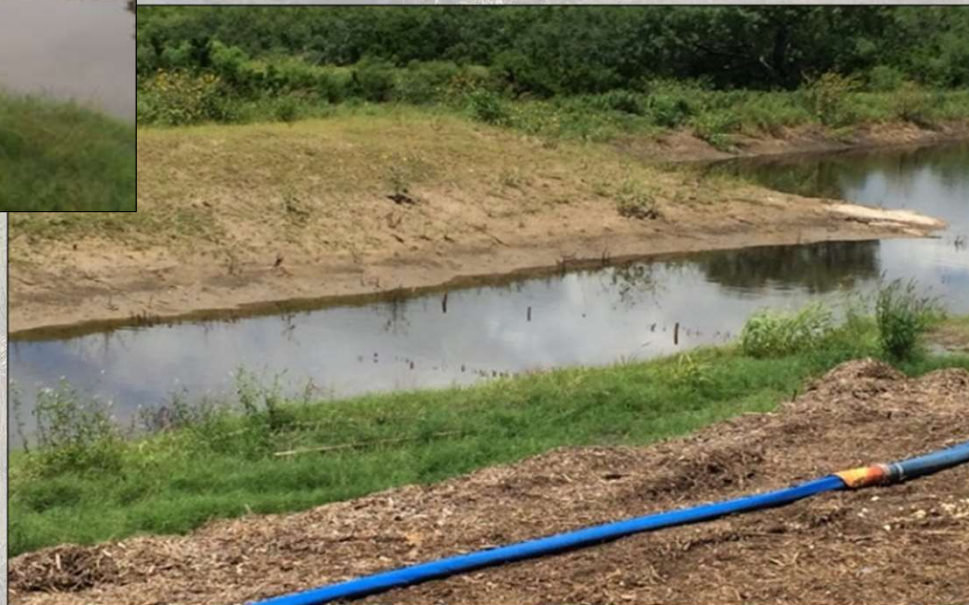
**July 2015 - Submerged Vetiver rows in canal  
Replanting of the affected areas was carried out  
In October 2015.**

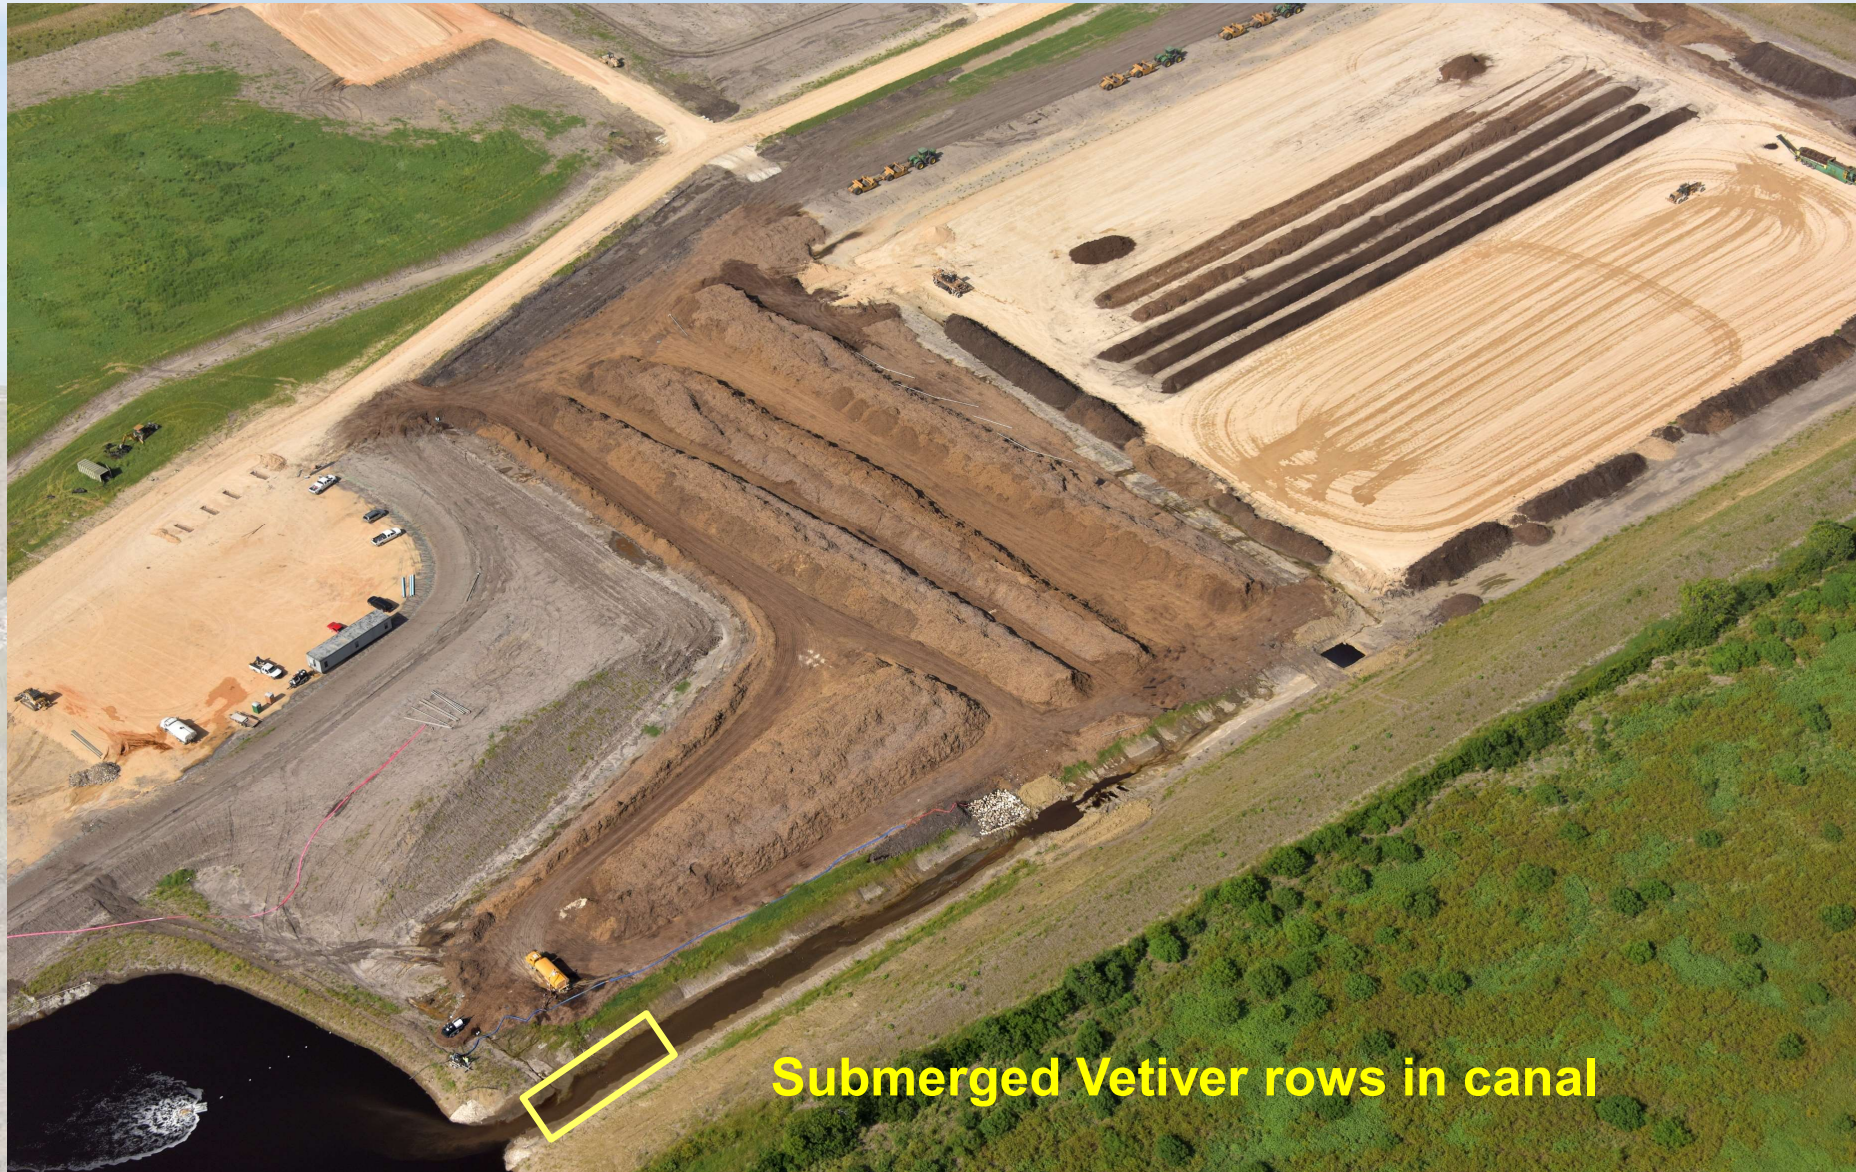
**Submerged Vetiver rows in canal**

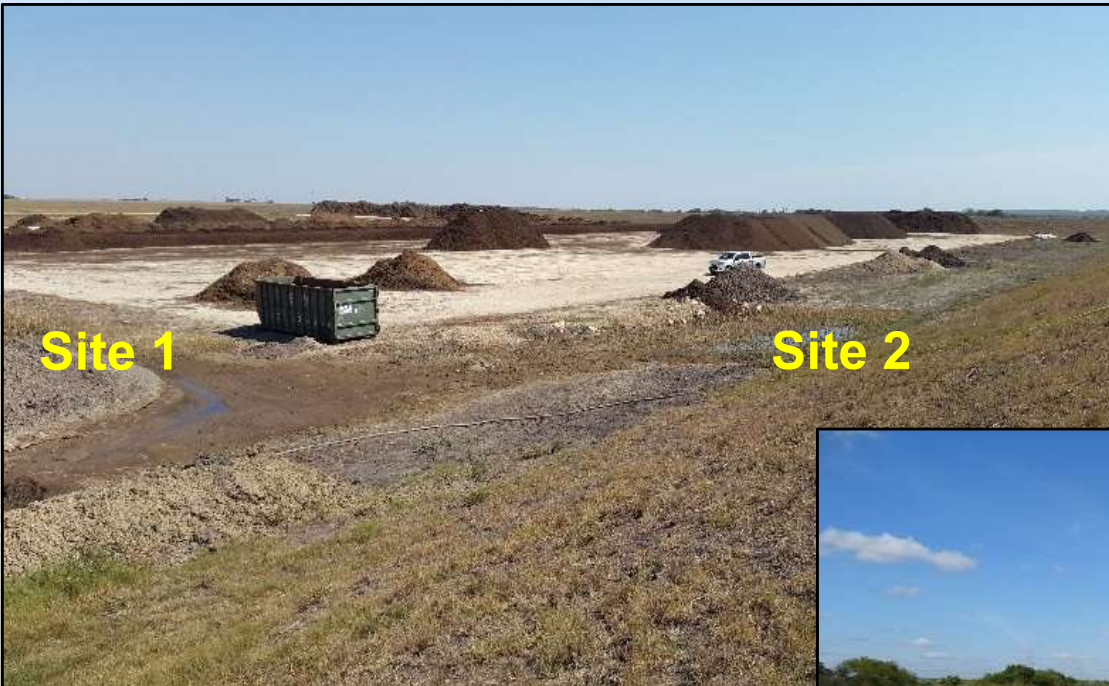
Sites 1 & 2 planted along the canal discharging leachate from the compost stockpiles into the canal leading into the retention pond.

Site 1

Site 2

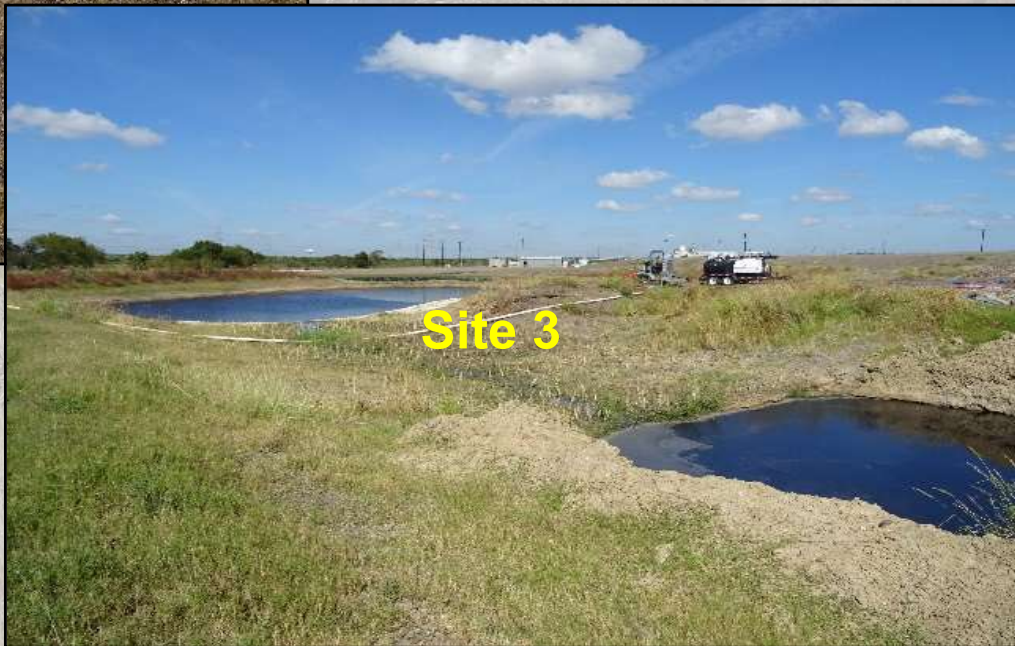
Site 3 planted downstream at the canal discharge end leading into the retention pond

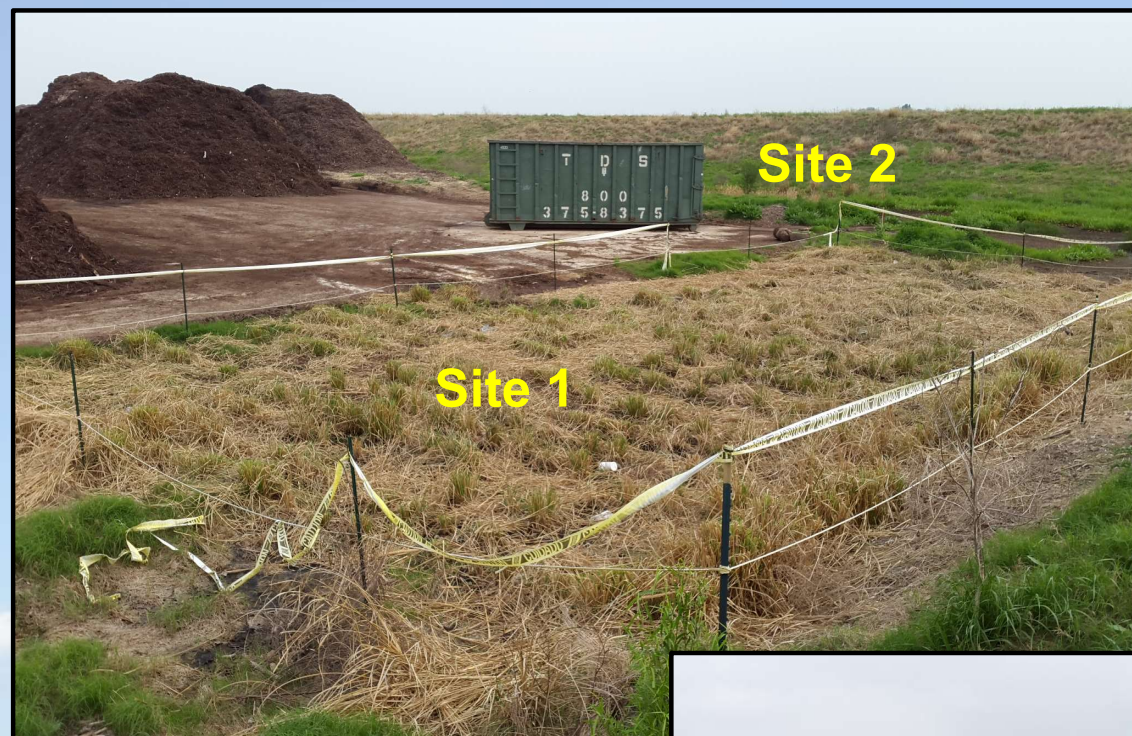
**Site 1 & 2 after mowing & removal of thatch. Paddock area well established after grass dormancy requiring removal of harvested material**

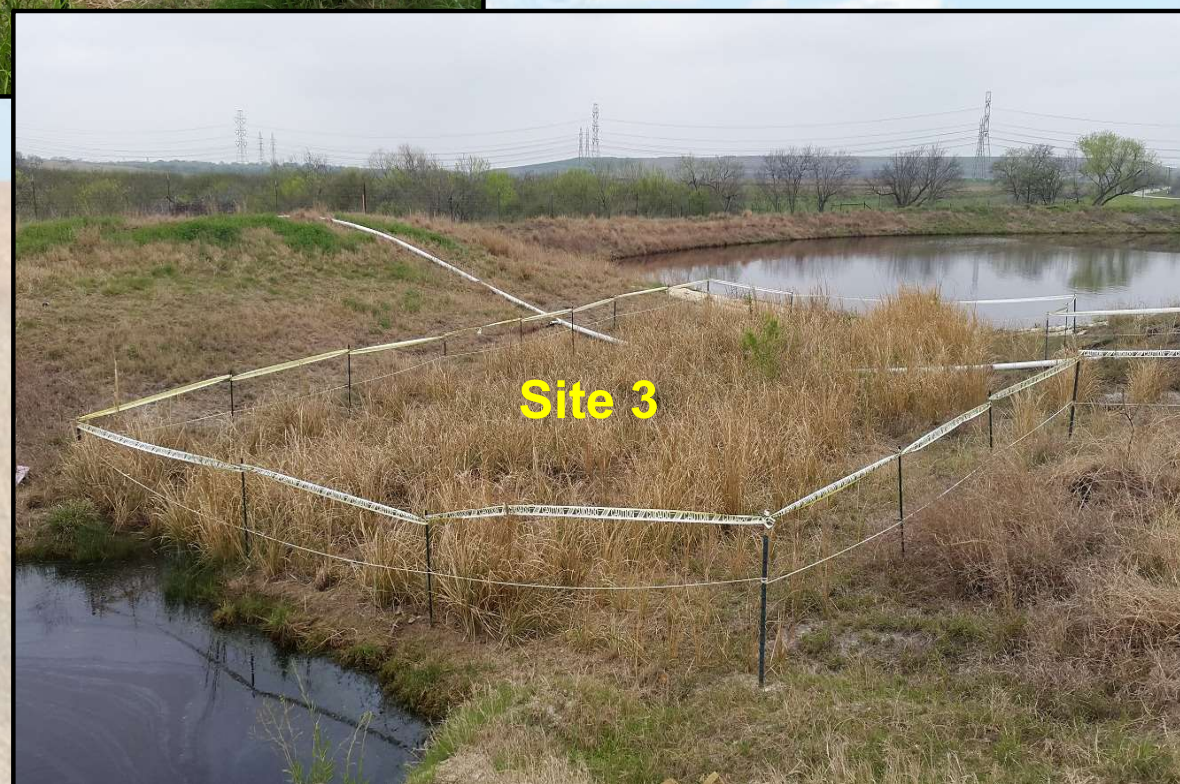
**September 2017 - The Vetiver grass had established well with regular maintenance over the 2016 & 2017 growing period. A wet September further assisted in plant growth.**

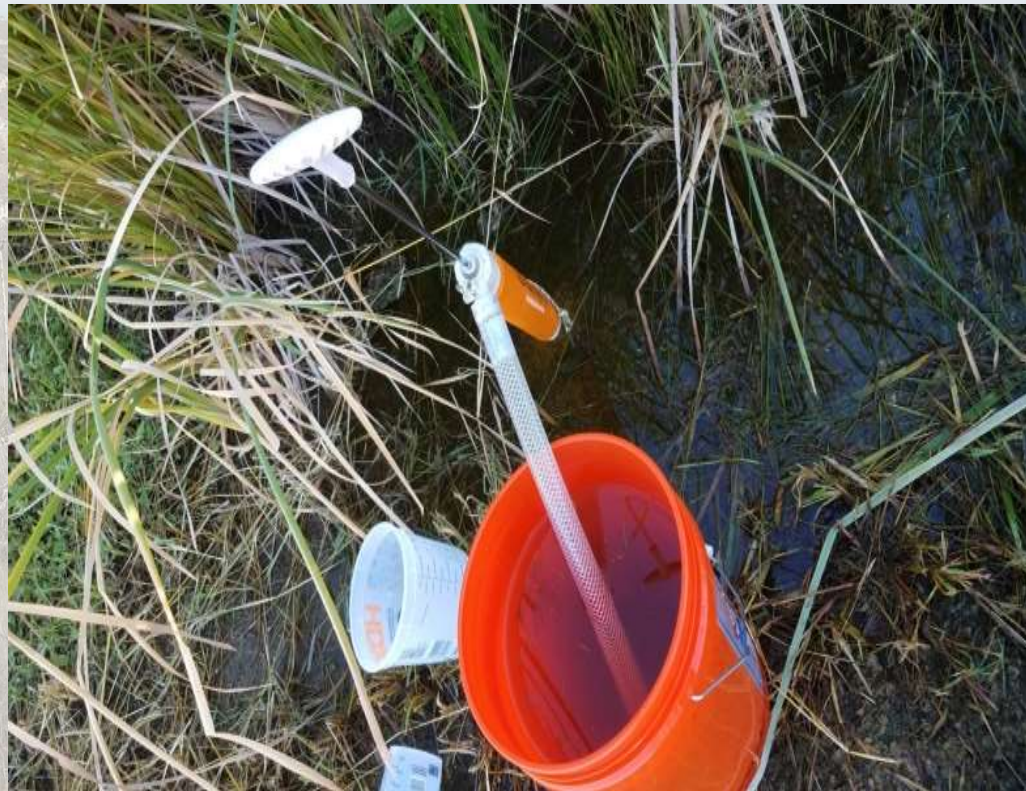
**A submersible hand pump was used to pump water into a bucket. Samples were poured into separate containers provided by SARA for lab analysis.**

**Samples stored on ice & delivered within 3 hours of collection to the SARA Regional Environmental Laboratory, 600 East Euclid San Antonio TX, 78212. Samples numbered S1, S2 & S3**
