APPLICATIONS OF VETIVER SYSTEM TECHNOLOGY FOR LAKE SHORE PROTECTION IN BRAZIL

Paula Leao¹, Aloisio Pereira¹ and Paul Truong²

¹Deflor Bioengenharia Belo Horizonte, Minas Gerais, Brazil

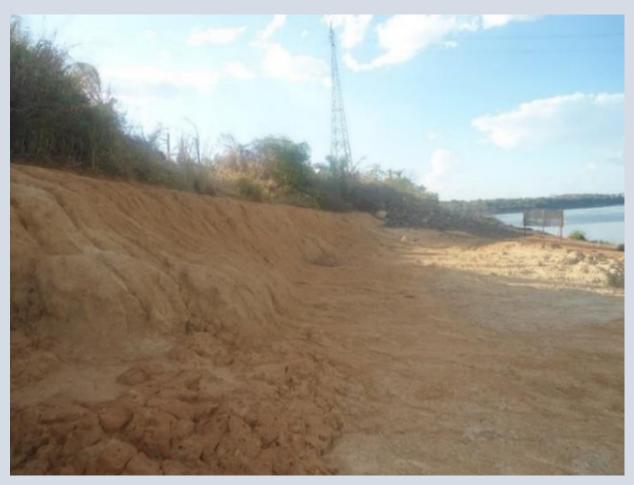
Baren lake shore exposed to wind water erosion er planting

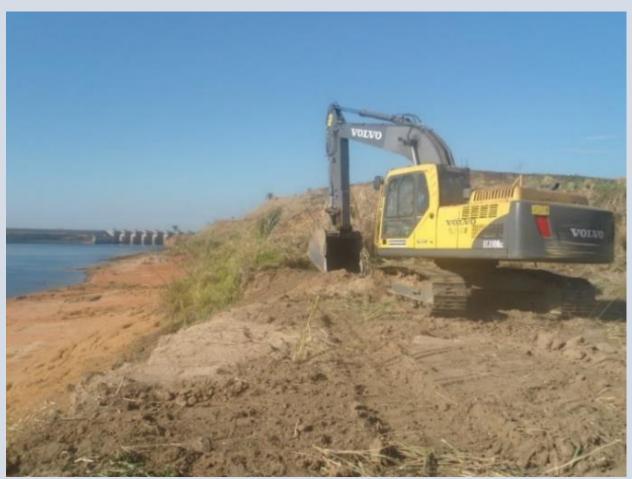
Site preparation for Vetiver planting

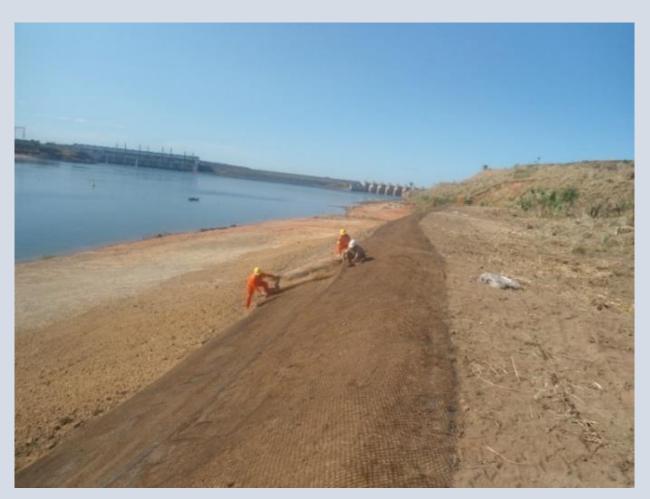
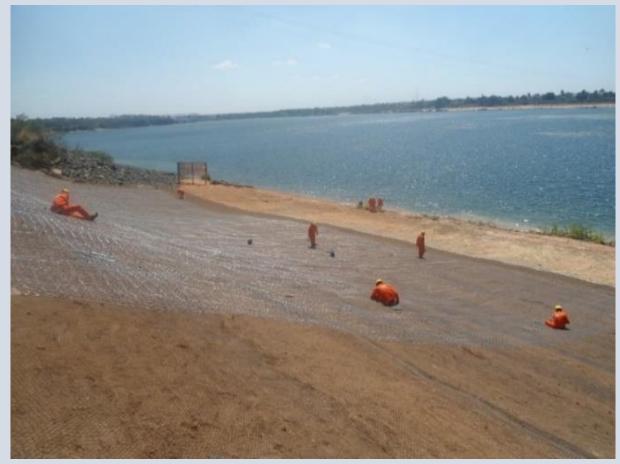
Site preparation for Vetiver planting

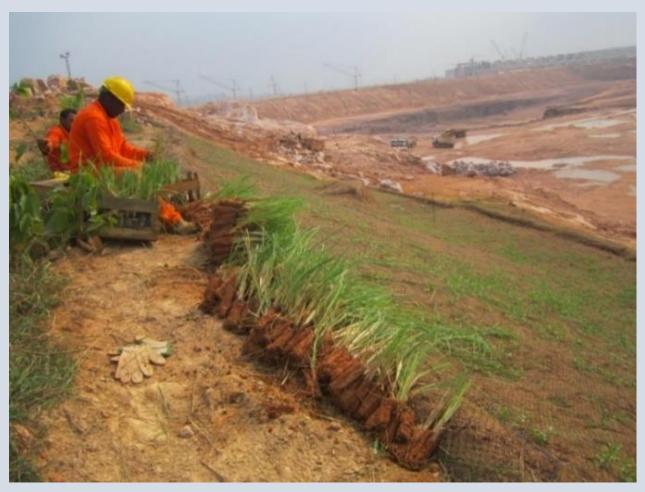
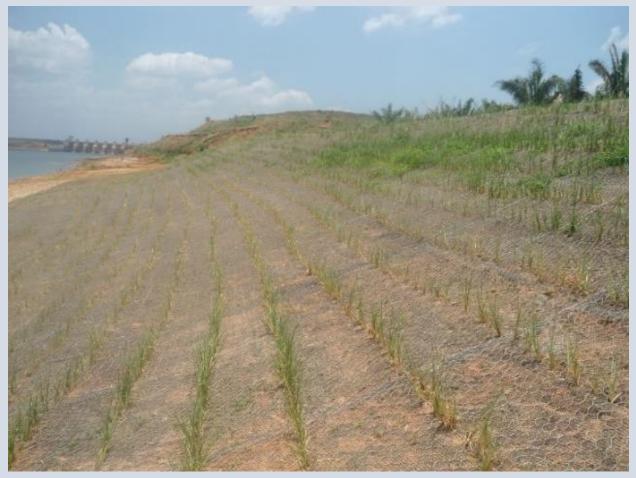
Potted Vetiver planting slips

Vetiver planting at 2m interval

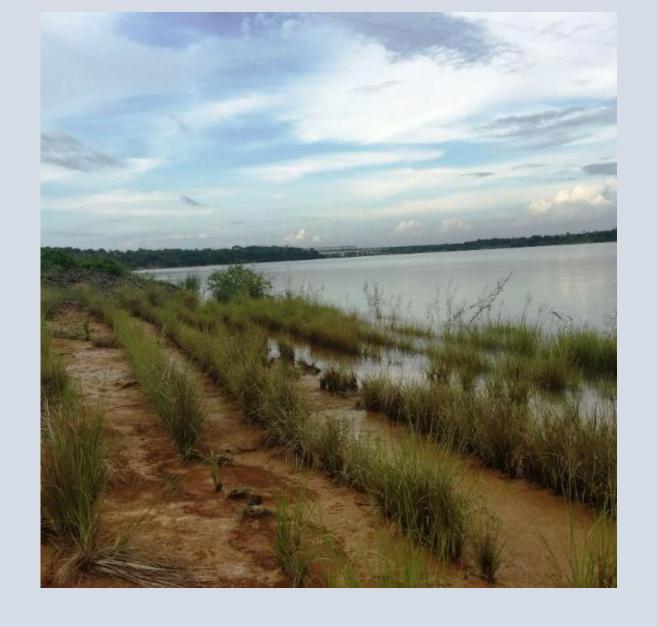
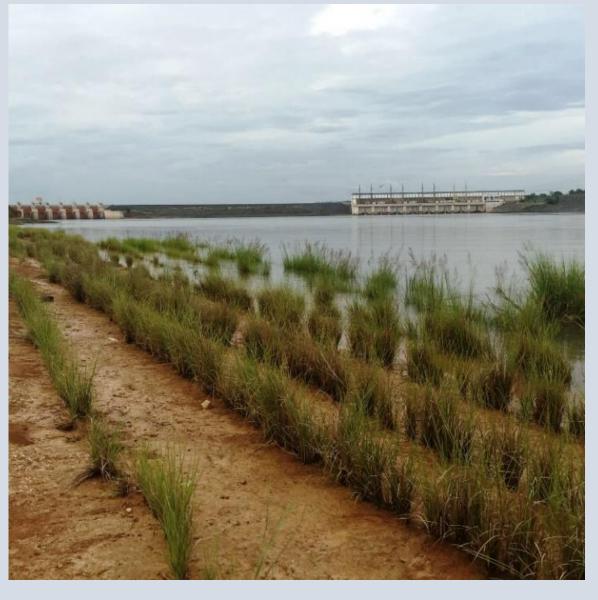
Six months after planting,

Vetiver was inundated after heavy rain overflow

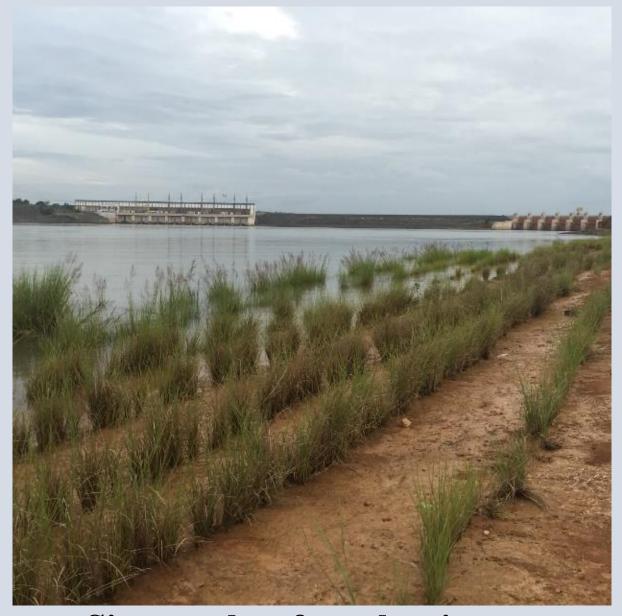
Six months after planting

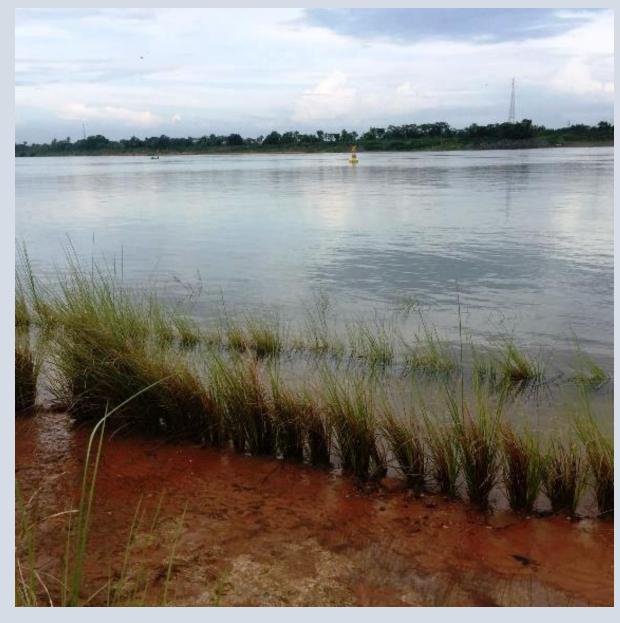
Vetiver was inundated after heavy rain overflow

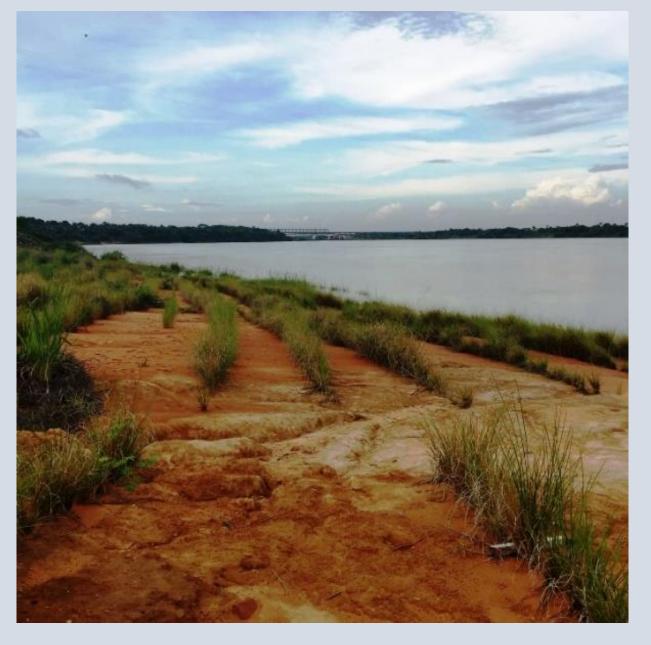
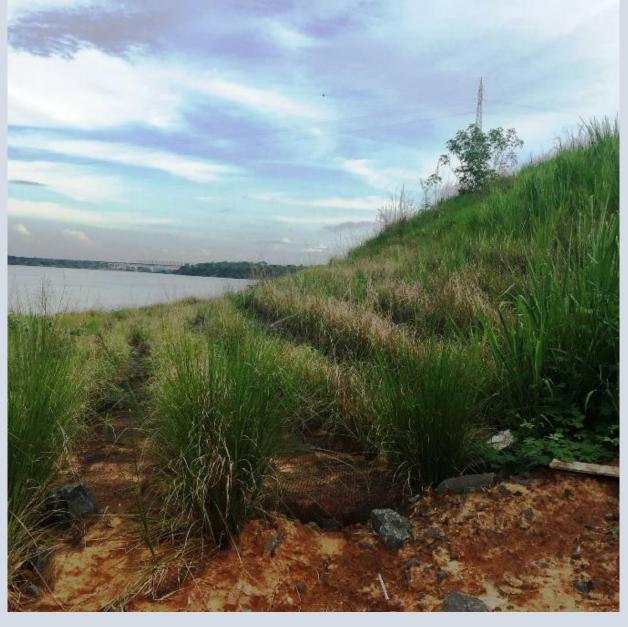
Growth recovered after heavy rain overflow receded

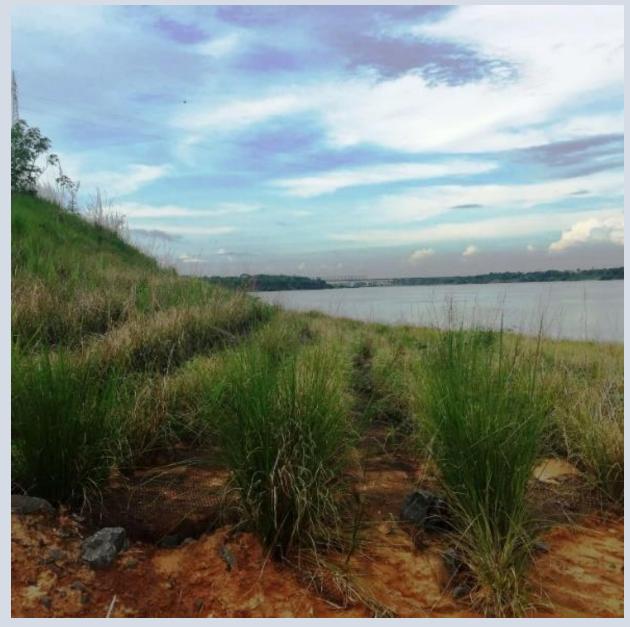
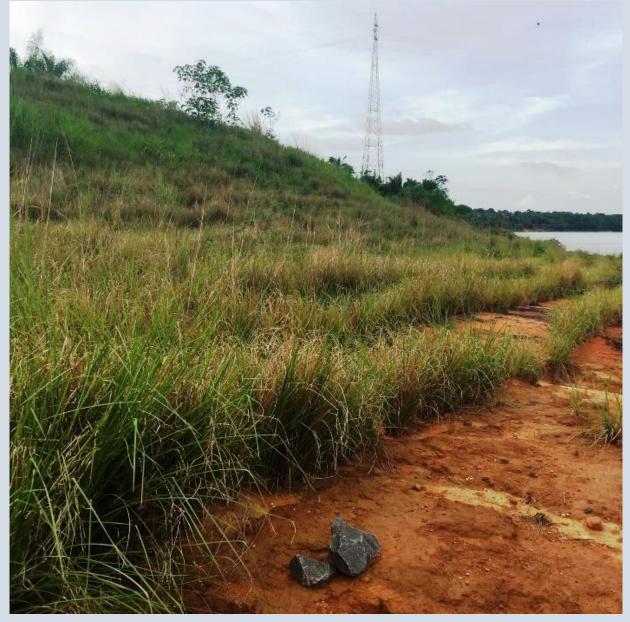
Growth recovered after heavy rain overflow receded

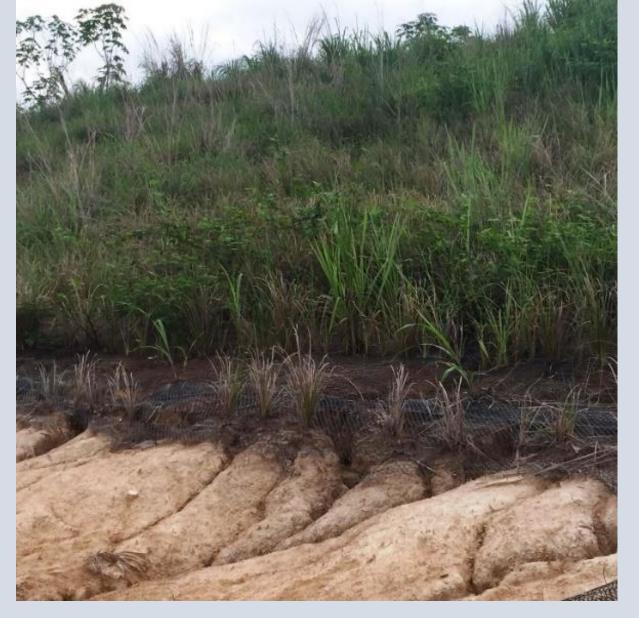
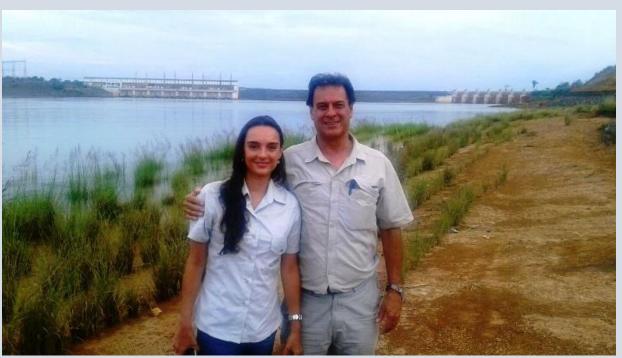
Growth recovered after heavy rain overflow receded
