VETIVER SYSTEMS APPLICATIONS
Highway Slope Protection along Kiunga – Tabubil Highway
PAPUA NEW GUINEA

EAGLE VETIVER SYSTEMS LIMITED
Green Solution for Sustainable Development

The project area is located on the Kiunga – Tabubil – Mine Highway in the Western Province, where approximately 900k+ vetiver slips were planted on 15 highway slopes, with initial trial in 2018 in order to reaffirm and verify the Vetiver Grass Technology for erosion control and stabilization of highways slopes.

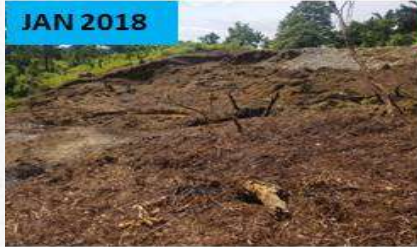
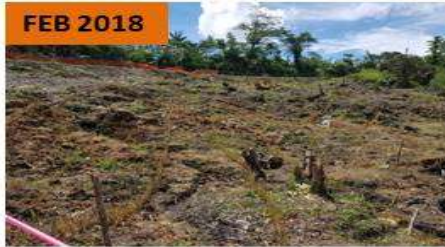
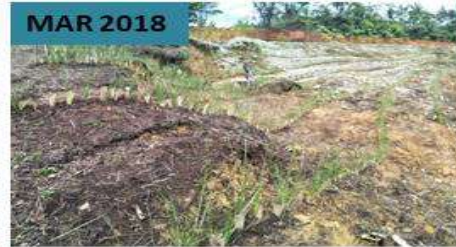
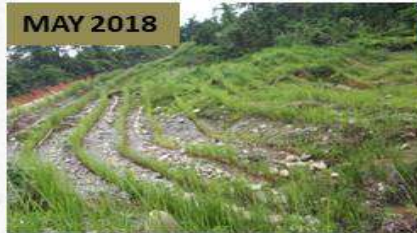
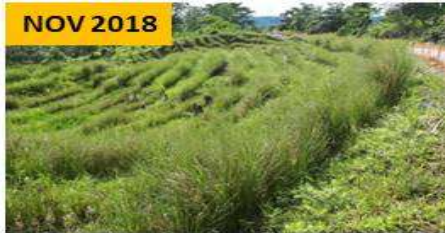
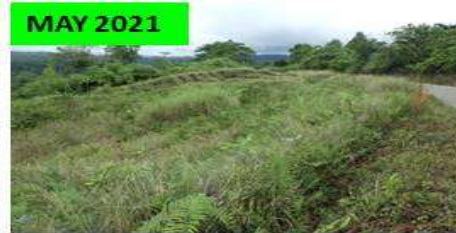
Pilot Trials (2018)

Results from a slope stability trial using Vetiver in Tabubil has shown significant movement reduction hence improving stability.

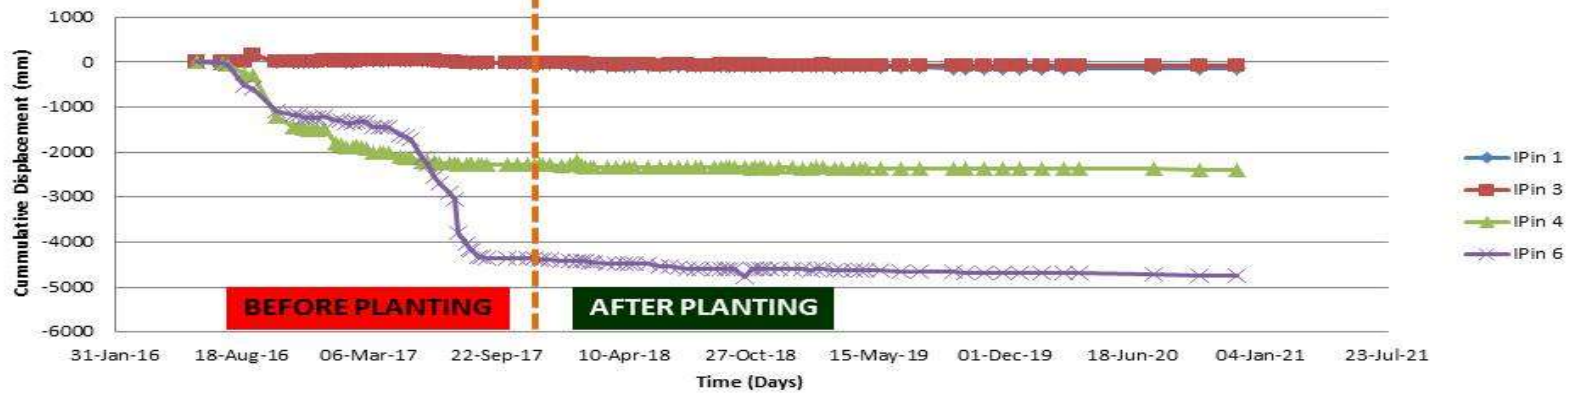
Cummulative Elevation Trend - Vetiver Grass Trial

The power of the **LIVING SOIL NAIL**.

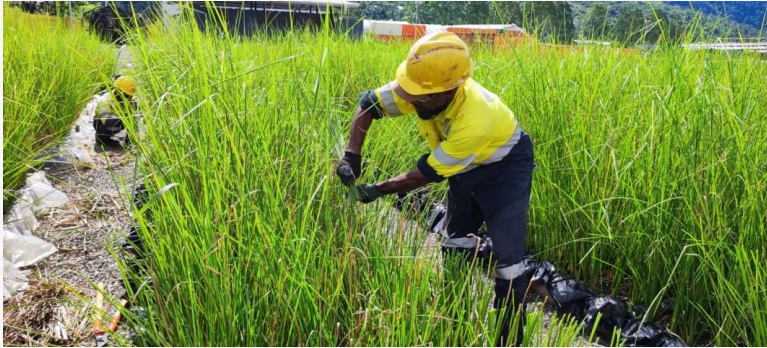
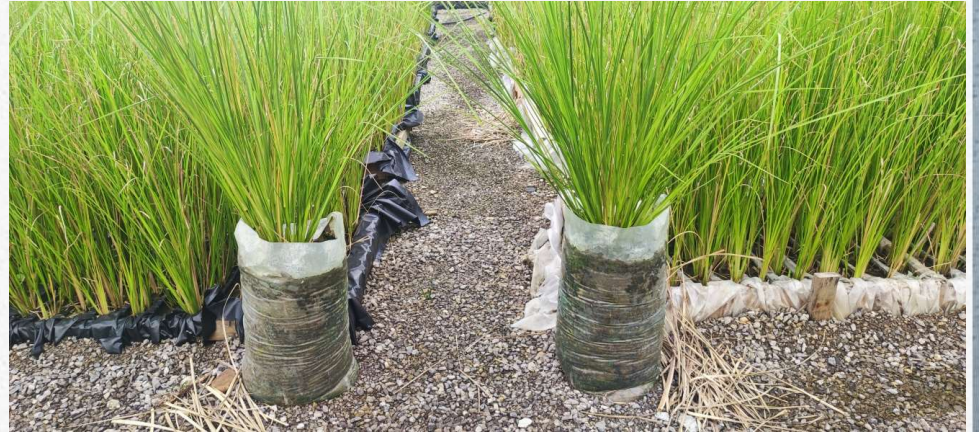
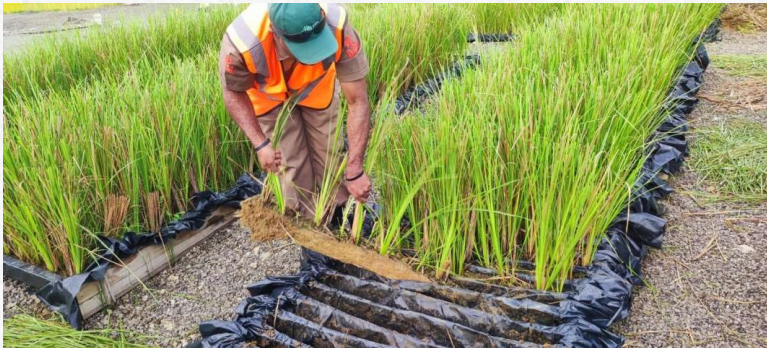
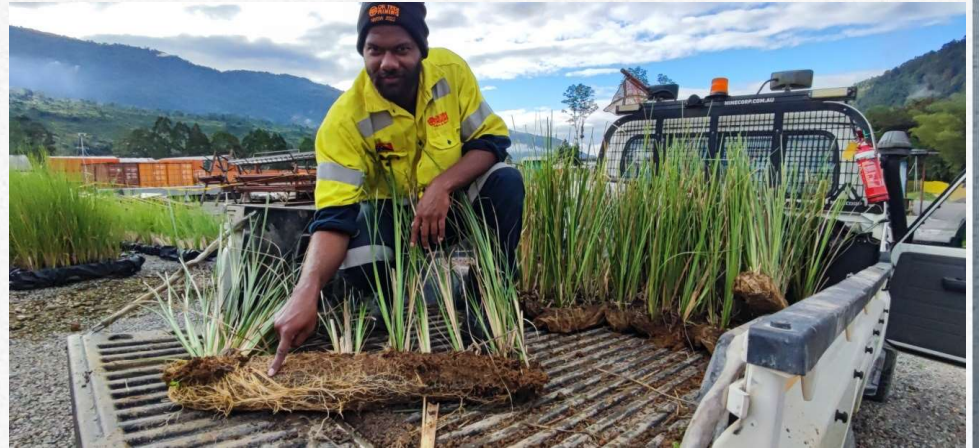
SITE NURSERY

We had a nursery established on site to provide us quality planting materials for our on going project. This was important for the success of the project.

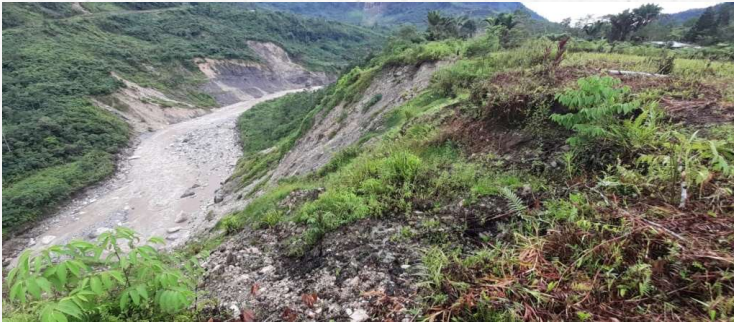
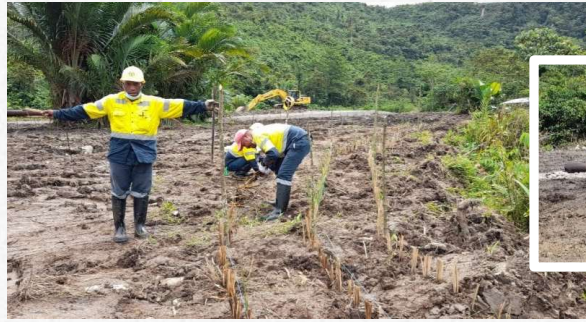
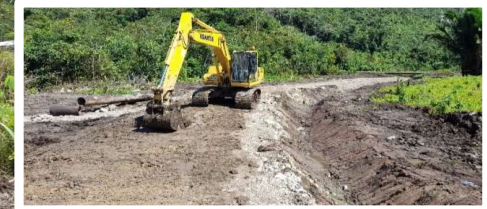
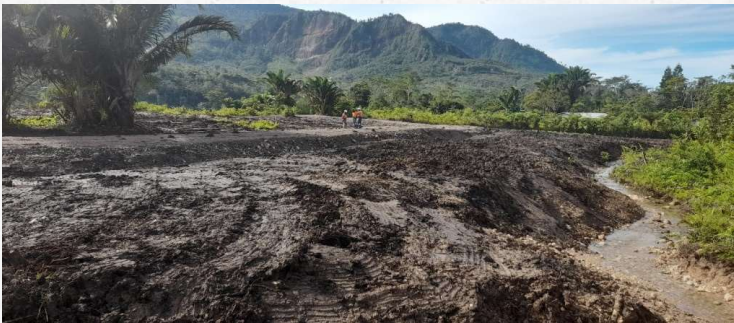
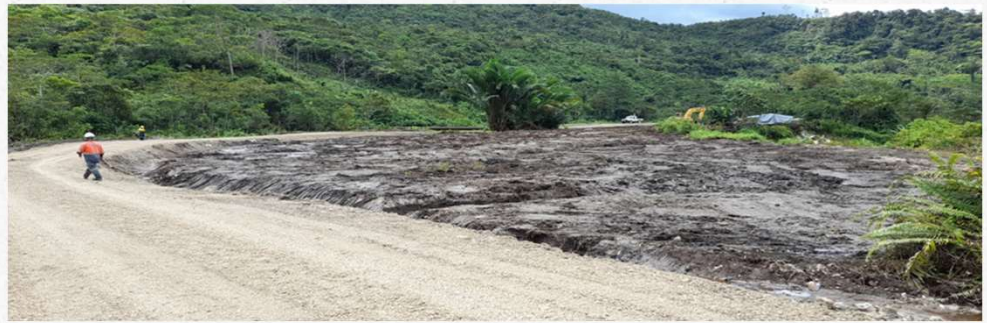
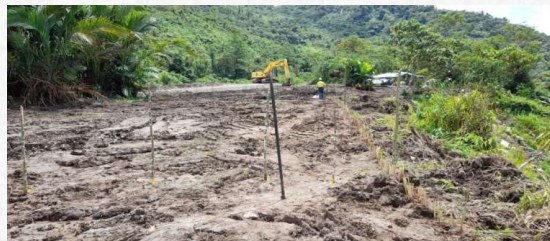
KM147 Significant Erosion & Slumping

These slope face immediately below the mine road has been subjected to progressive toe erosion by the Ok Tedi River navigating its way downstream. The slope comprises of soft to firm mudstone unit at the base and is overlain by unconsolidated limestone rubble from the historic Hindenburg landslide.

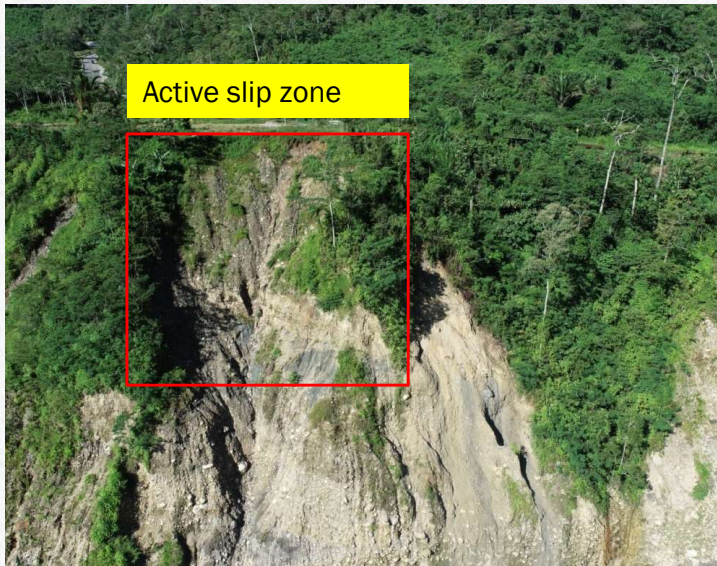
Active slip zone

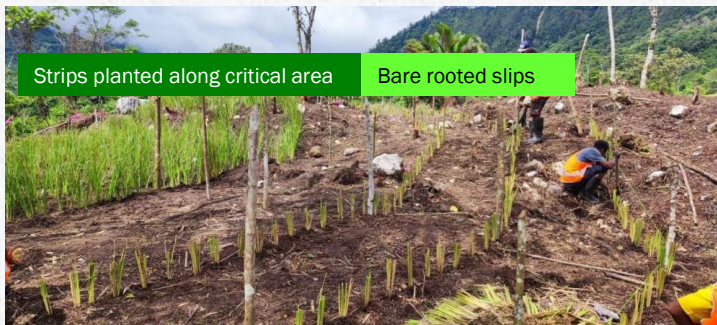
Strips planted along critical area

Bare rooted slips

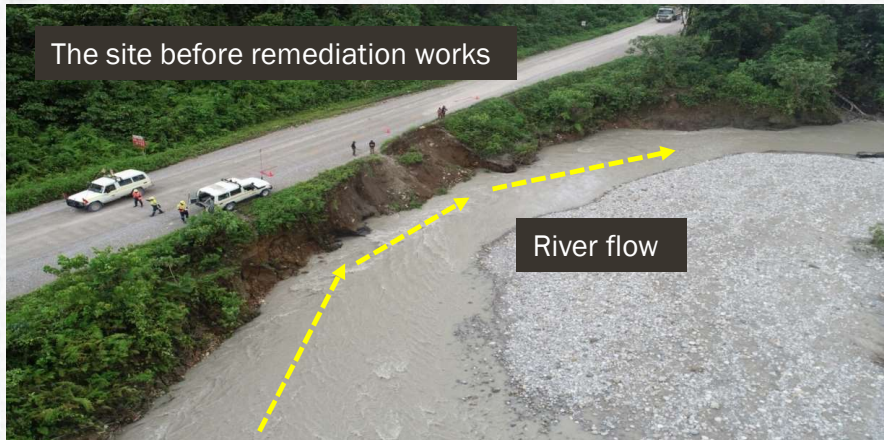
The site before remediation works

River flow

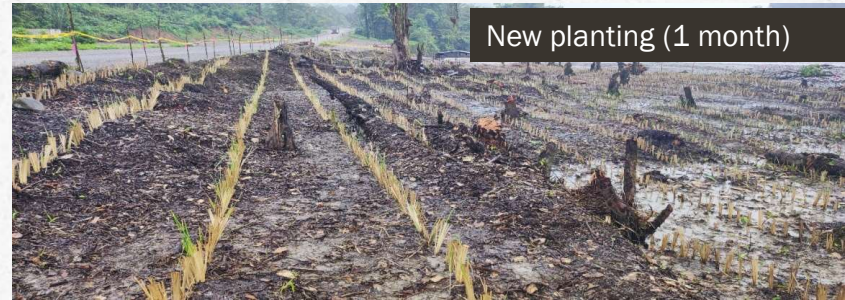
New planting (1 month)

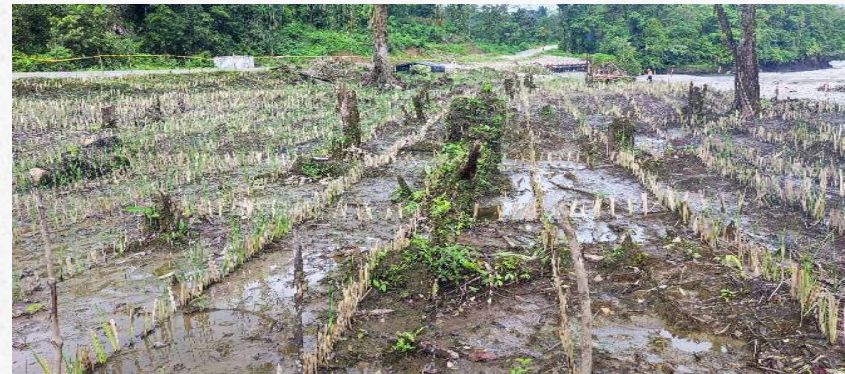
New planting (4 months)
